Phase I Environmental Site Assessment of the  
Castaneda Building Property  
524 Railroad Avenue, Las Vegas,  
San Miguel County, New Mexico

**June 6, 2014**

GL Environmental, Inc.  
P.O. Box 1746  
Las Vegas, NM 87701  
(505) 454-0830

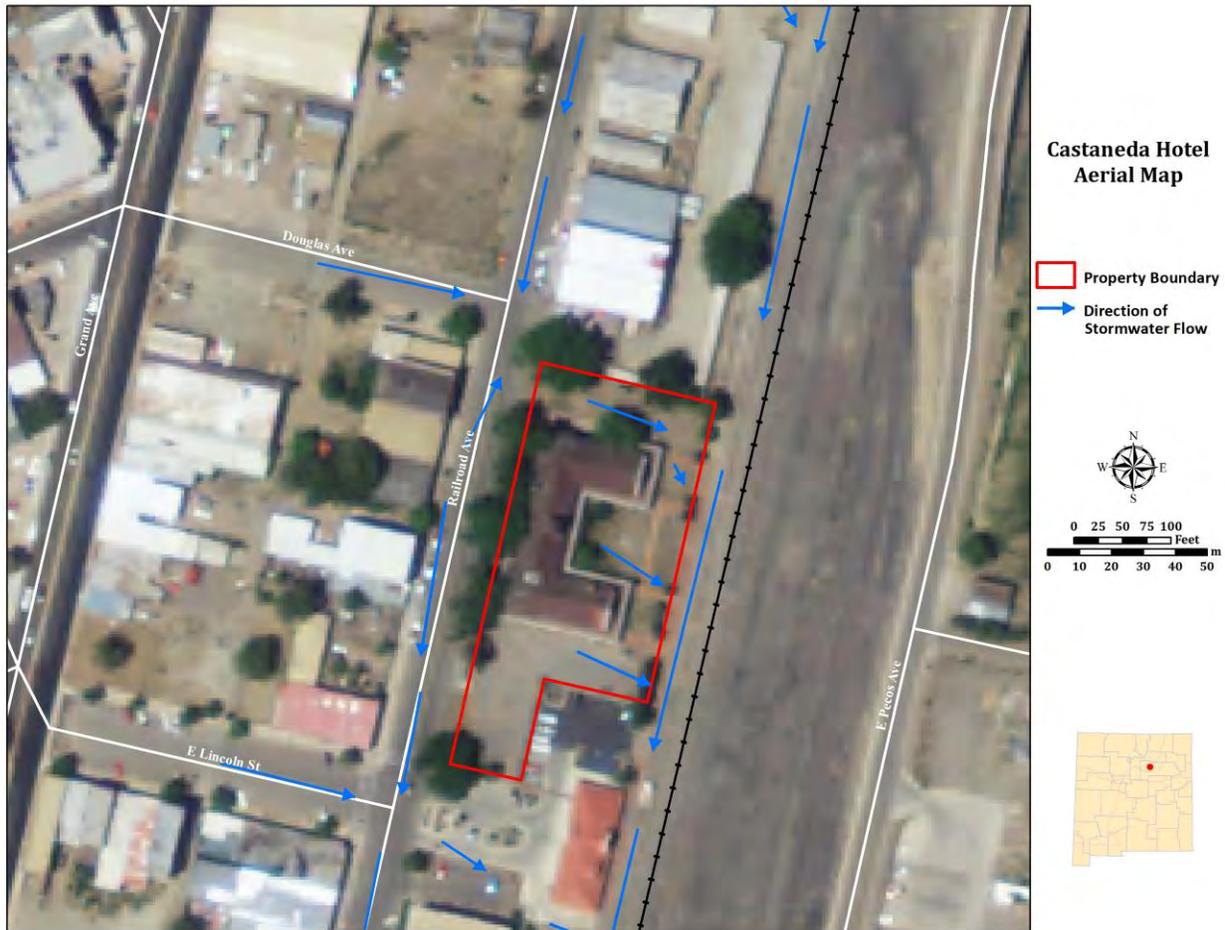
Figure 3. Surface water flow diagram

The Target Property slopes gradually from west to east at an approximate 1.5% grade. Stormwater generated on the property appears to drain east as sheet flow into the railroad right-of-way. No stormwater impoundments are present on the Target Property. No indications of stormwater run on from adjacent properties to the Target Property were observed. However, during intense precipitation events, the subsurface storm drains along Railroad Ave may become overwhelmed, in which case surface water may flow across the property into the railroad right-of-way.

Stormwater generated on the property appears to drain east into the railway right-of-way. Some stormwater from the parking area may drain onto Railroad Avenue. No indications of surface water run-on from adjacent properties to the Target Property were observed. No stormwater impoundments or engineered drainage structures are present on the Target Property.

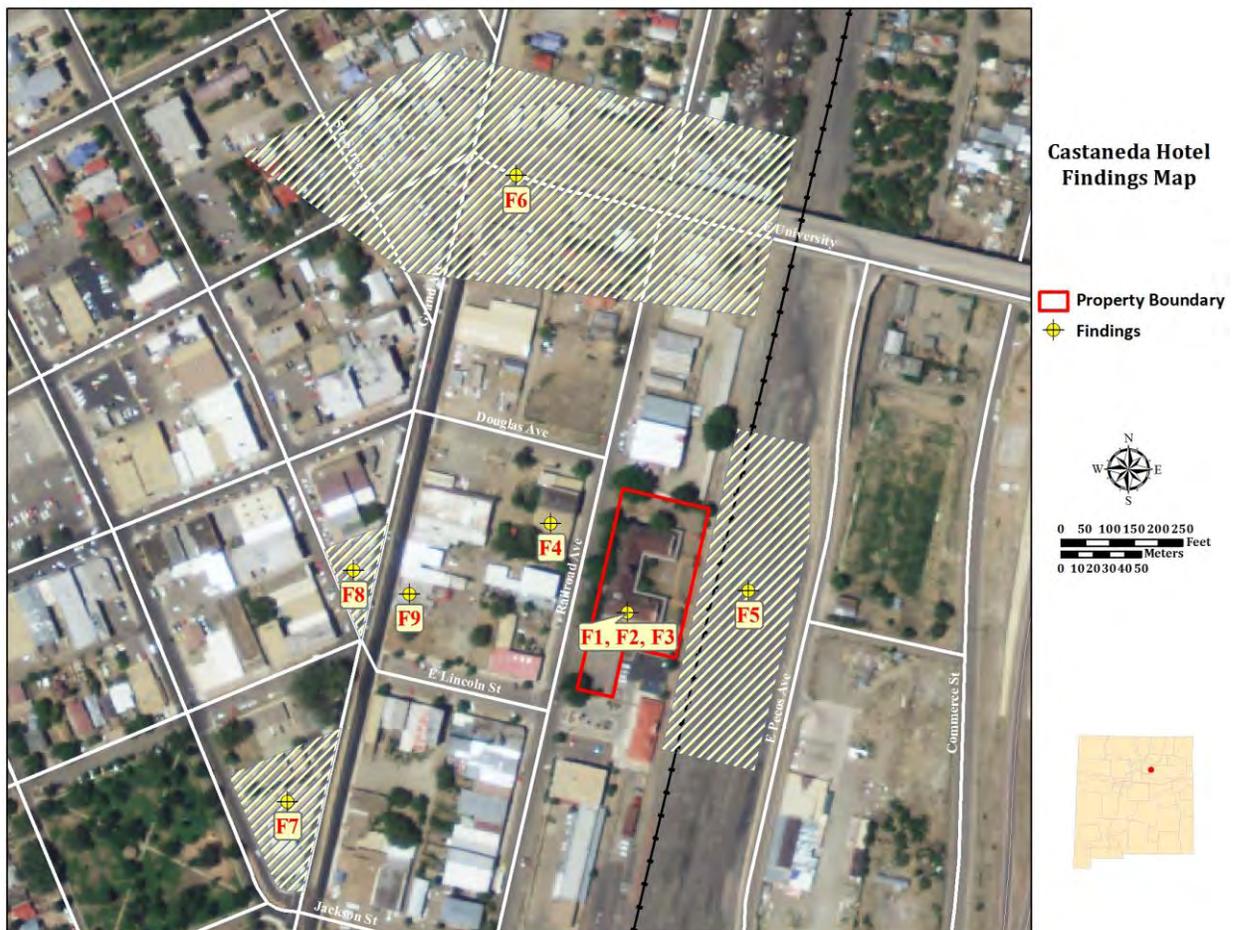
Figure 4. Findings

The ESA records review, site reconnaissance, and interviews identified 1) **three** sites within the Target Property 2) **two** sites on adjoining properties, and 3) **four** sites on non-adjoining properties which could potentially release hazardous materials and/or petroleum products onto the Target property. These properties, referred to as findings, are discussed in detail below. Findings within the Target Property, Findings that adjoin the Target Property, and Findings that do not adjoin the Target Property are presented in different sections. The locations of Findings are illustrated on Figure 4.

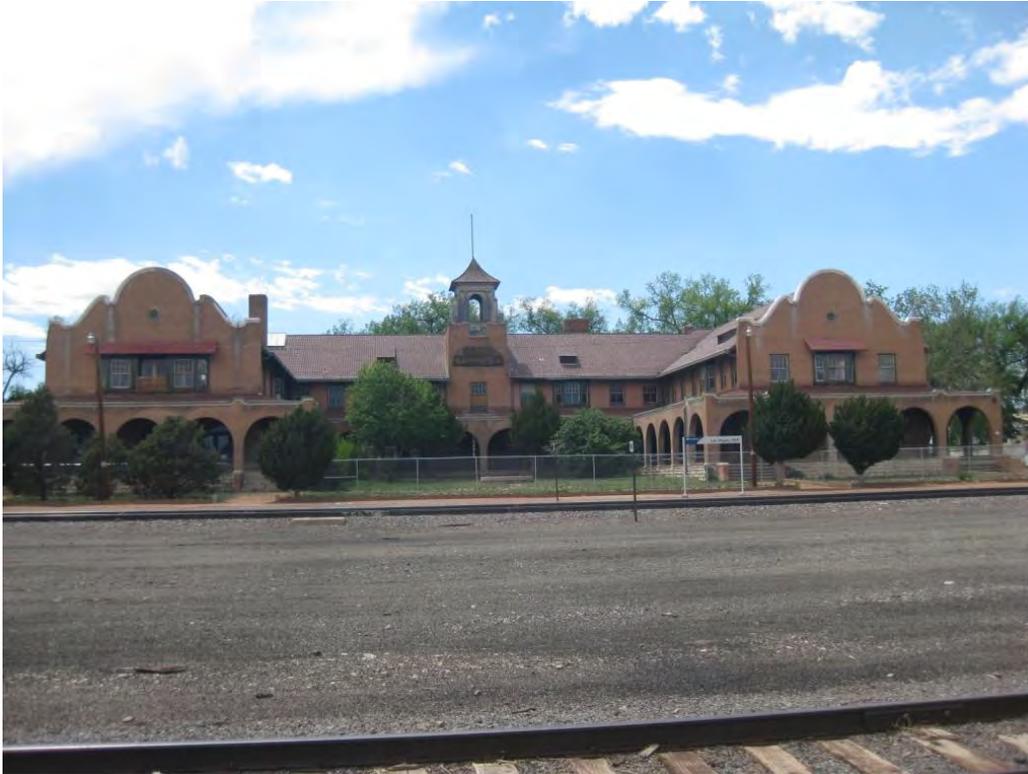
Photo 1. Hotel Building (facing west)

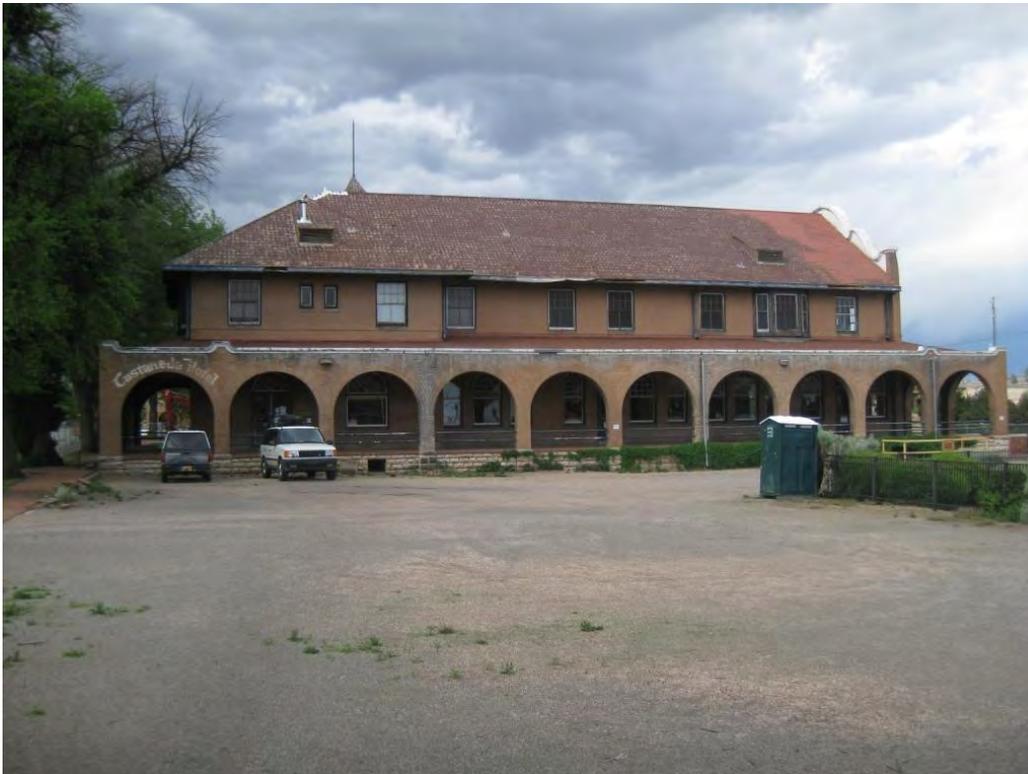
Photo 2. Hotel Building (facing north)

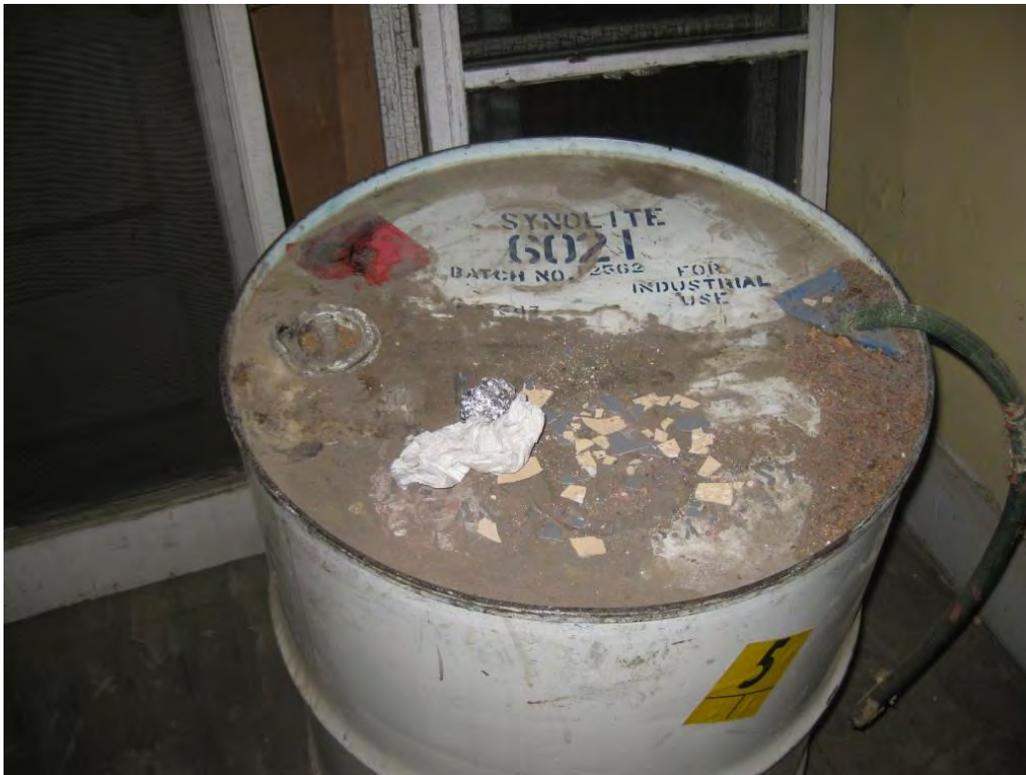
An approximate 50 gallon drum labeled Synolite 6021 is located in one of the guest rooms in the north wing of the first floor. Synolite products are polyester resins that contains styrene and are used for material surfacing or fiberglass casting. Materials that contain styrene in excess of threshold concentrations may be considered hazardous substances. If the contents of the drum is Synolite 6021 the styrene concentration and therefore hazardous materials status is unknown. The tank appears to be in good condition with no signs of leaks.

Photo 3. Drum labeled Synolite 6021

**F2 Synolite Drum** – Although this product may be considered a hazardous material for disposal purposes, the tank appears to be in good condition with no signs of leaks. This finding is not a REC.

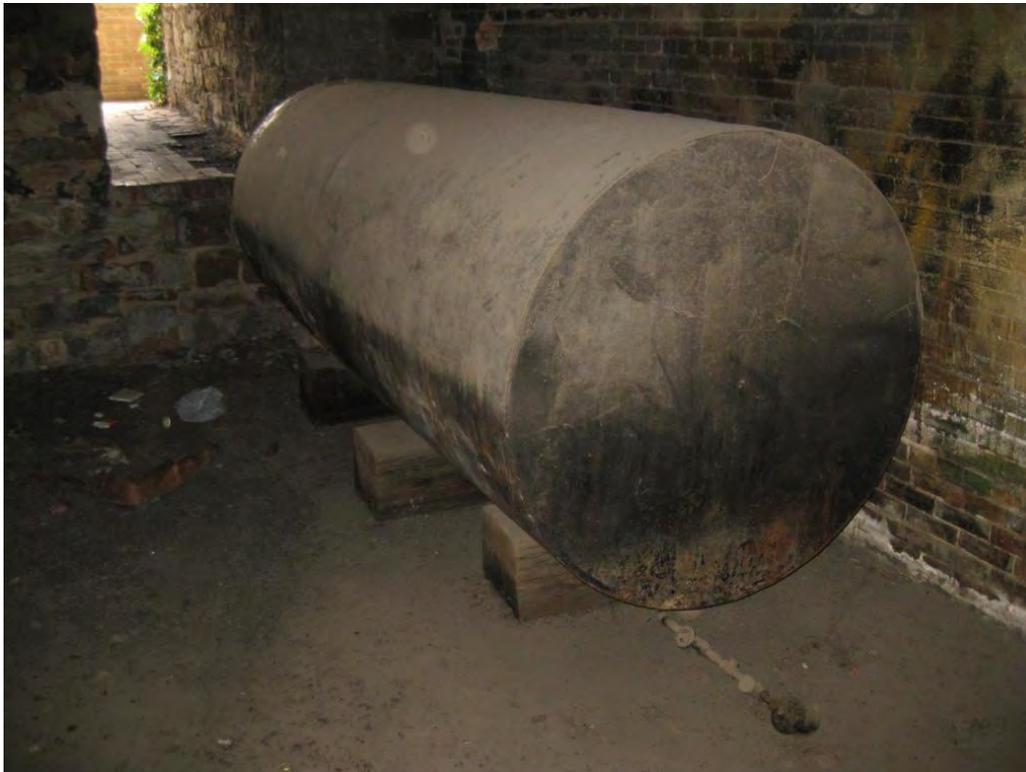
A 1,000 gallon tank, possibly used to store heating oil, is located in the basement in a room adjacent to the boiler room. Information could not be obtained to definitively determine the tanks history of use including purpose, length of service, or if any released of petroleum products occurred. No staining or other indications of petroleum product release were observed in the vicinity of the tank or boiler room.

Photo 4. 1,000 gal steel tank

Due to the presence of a REC, potential petroleum storage tank on the Target Property and the nature of the surrounding vicinity, GL would strongly recommend conducting soil sampling that extends to the depth of any proposed disturbance prior to any excavations associated with construction / rehabilitation activities at the Target property to determine the presence of hazardous material or petroleum products.

**F3 Steel Tank** – The tanks history of use including purpose, length of service, or if any released of petroleum products occurred is unknown. No staining or other indications of a release of petroleum products were observed in the vicinity of the tank or boiler room. This finding is not a REC.

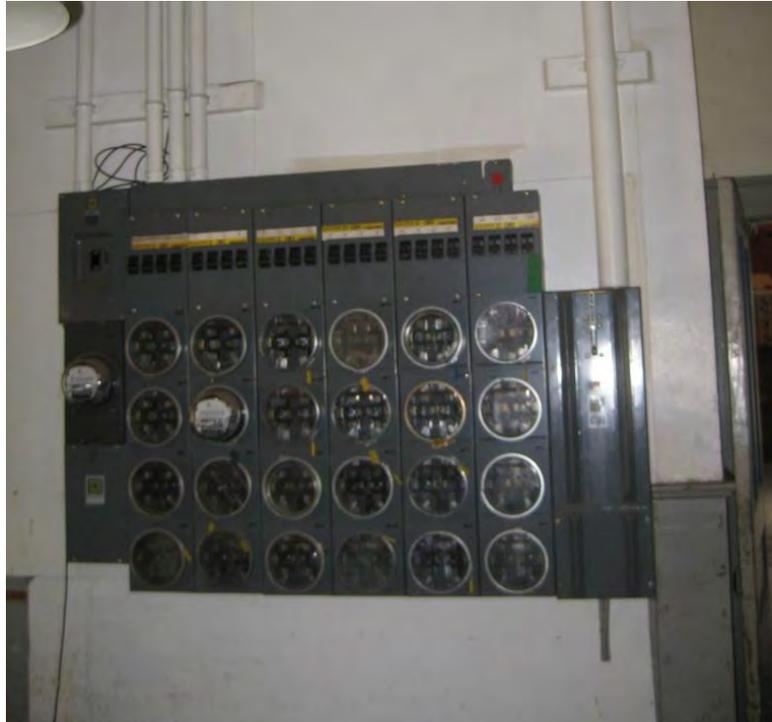
The Target Property electrical system components located in the kitchen and other parts of the building may contain PCB oils, a hazardous material (See Appendix C, Photo 5-6). No leaks or stains were observed on electrical equipment or in their immediate vicinity that would suggest a release of oils occurred from the electrical components.

Photo 5. Electrical Components

**F1 Target property Electrical System** – No leaks or stains were observed on electrical equipment or in their immediate vicinity that would suggest a release of oils from the electrical components. This finding is not a REC.

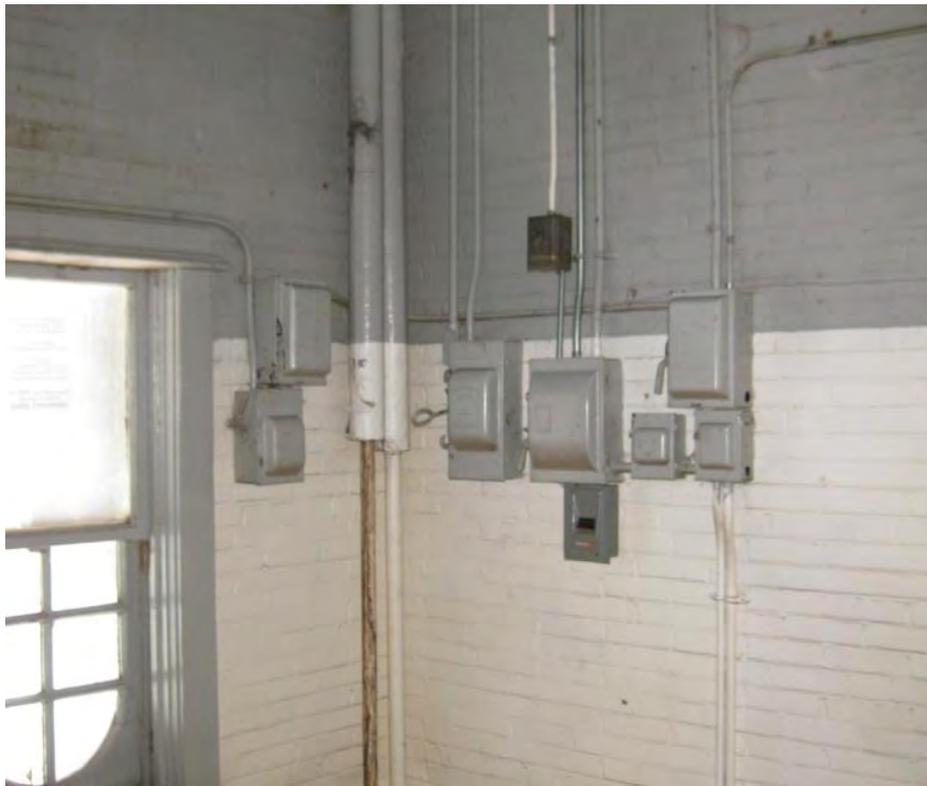
Photo 6. Electrical Components

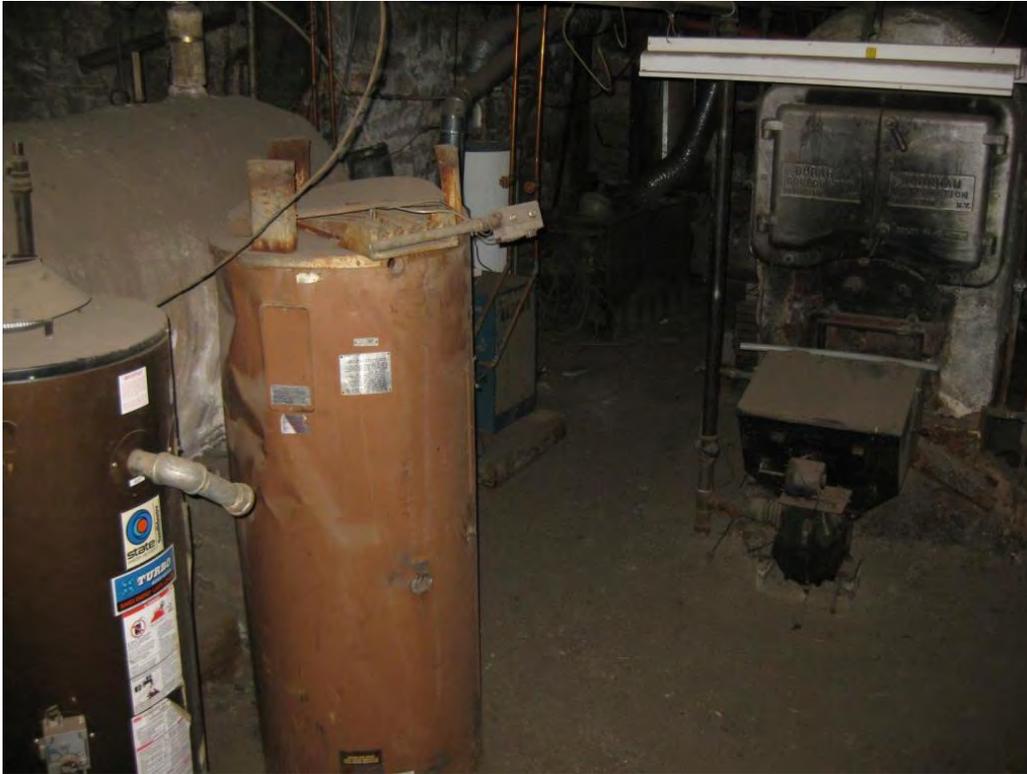
Photo 7. Boiler room

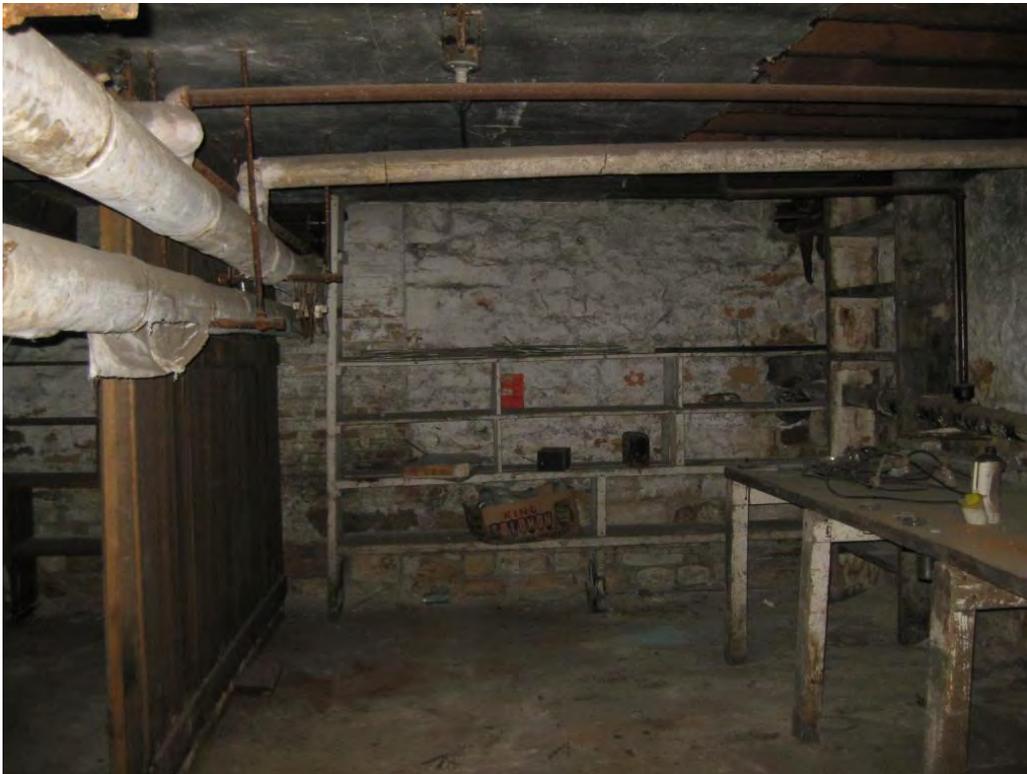
Photo 8. Basement in north wing
