**Lead Paint and Asbestos Containing Building Material
Inspection of the Rawlins Building
529 Railroad Avenue, Las Vegas
San Miguel County, New Mexico**

**PREPARED FOR:
Main Street de Las Vegas and
Allan Affeldt**

June 13, 2014

**GL Environmental, Inc.
P.O. Box 1746
Las Vegas, NM 87701
(505) 454-0830**

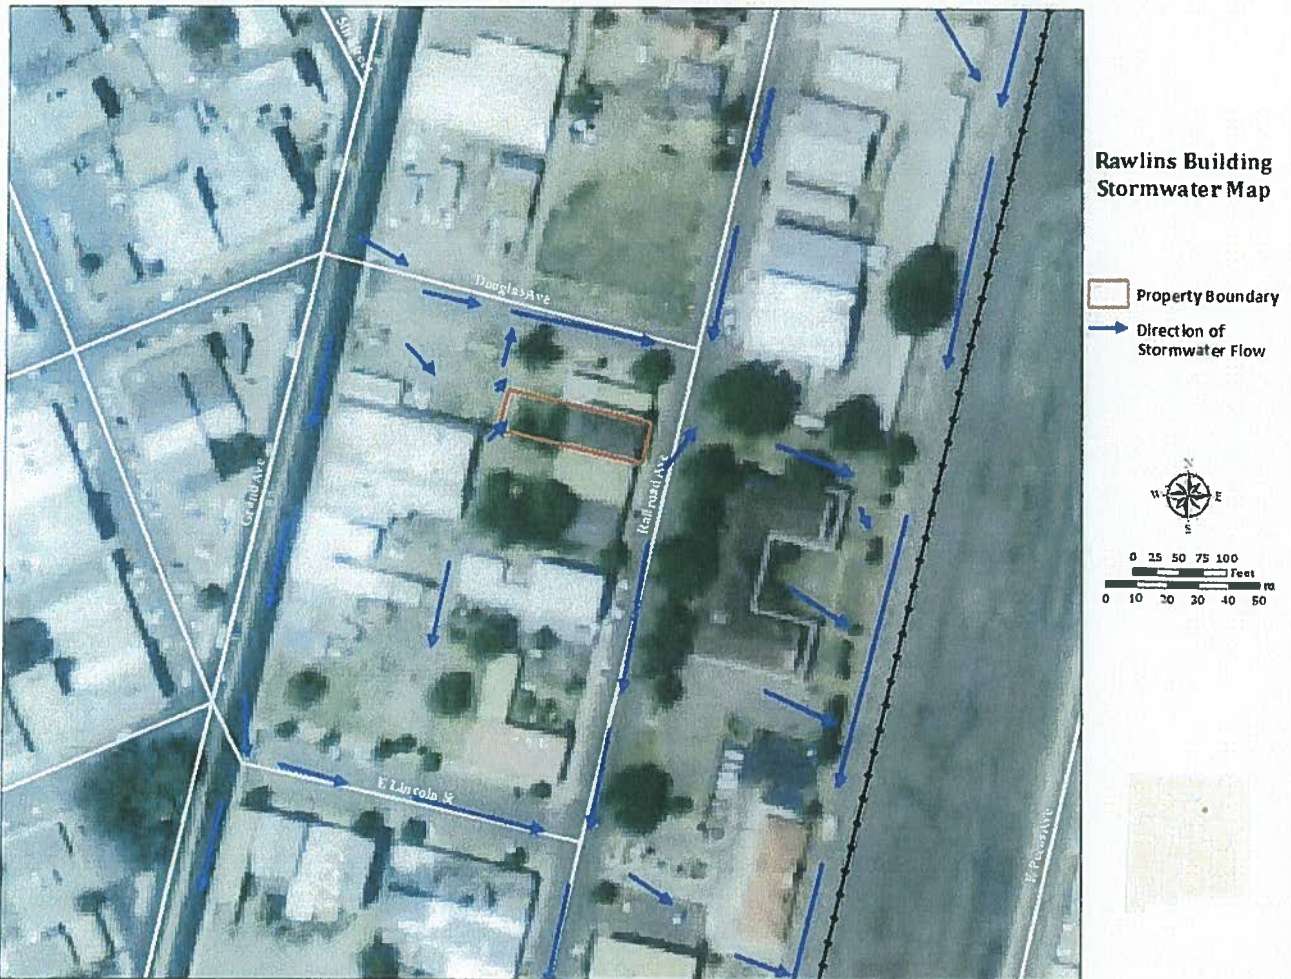
Figure 3. Surface water flow diagram

The Target Property is generally level. Stormwater generated on the property structure appears to drain east onto Railroad Avenue. Surface water generated in the alley to the west of the property may flow onto the Target Property during storm events. No stormwater impoundments or indications of significant ponding of surface water on the Target Property were observed.

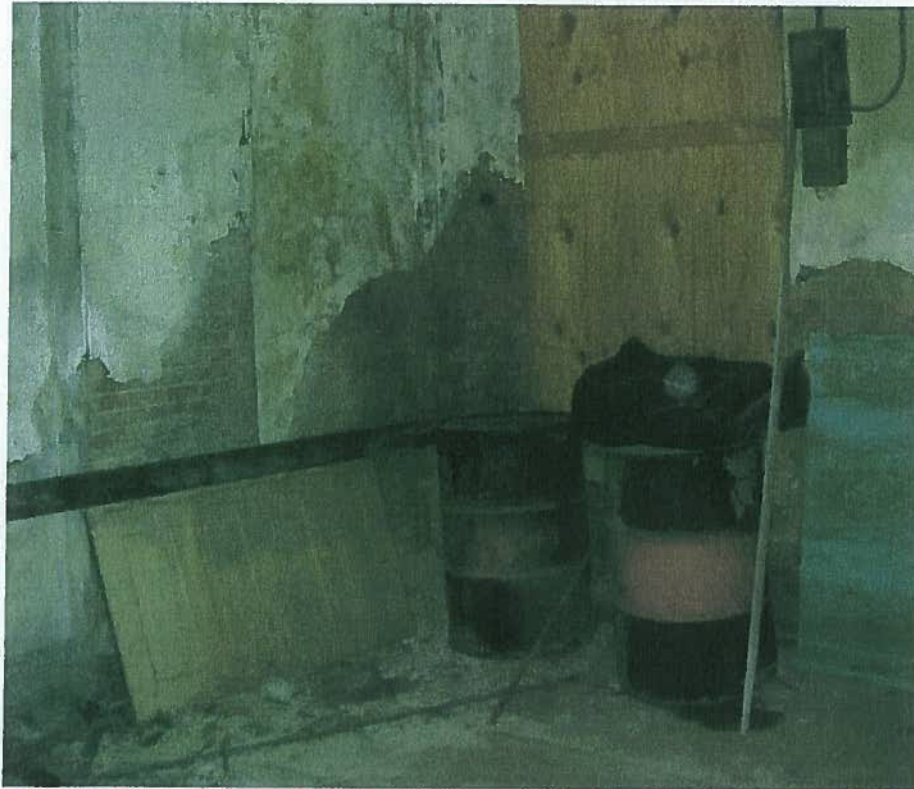
Photo 5. 50 gallon drums

Two approximate 50 gallon drums are located on the southwest end of the first floor (Appendix C, Photos 5 – 6). The drums are empty but a small amount of what appeared to be petroleum staining was present around the bottom of one of the drums.

F1 Two 50 Gallon Drums –The drums are empty with de minimus staining. There is no indications of a release of significant amounts of petroleum products associated with this finding. This finding is not a REC.
